## **Tech Note UV100-100**

### **Checking the UV-100 CALIBRATION WITH THE OG-3**

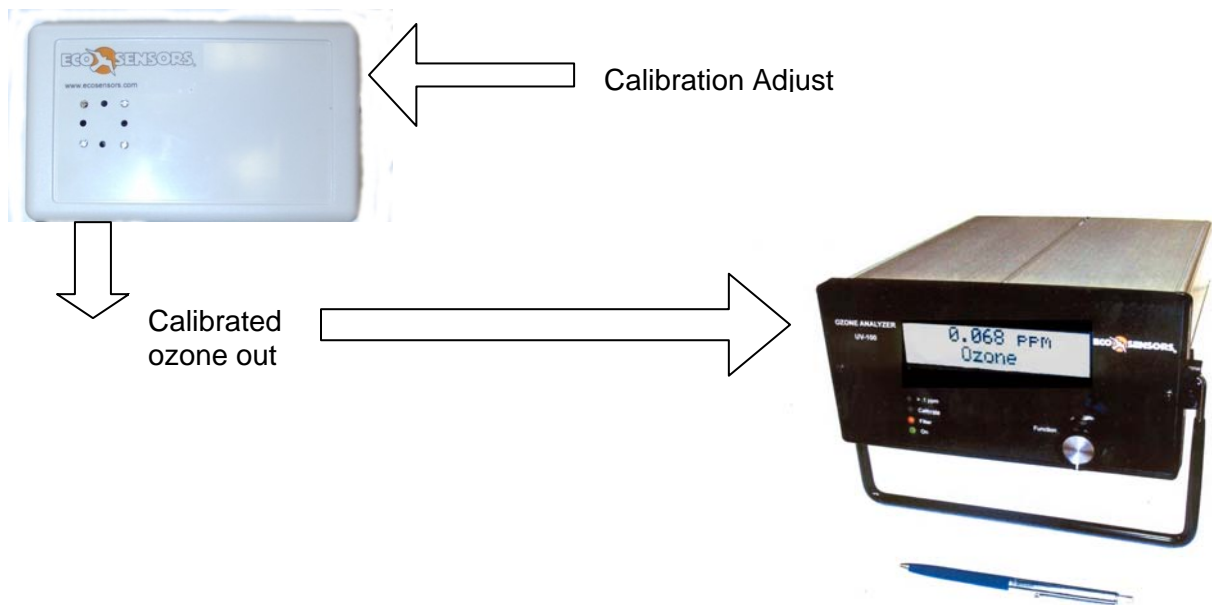
2 - Attach the short 10 mm (3/8") outside diameter tube to the UV-100 air filter input barb and fit its other end just inside the 10 mm hole on the bottom of the OG-3. Do not extend it far into the OG-3. A few mm is sufficient. Any further in will reduce the calibration accuracy.
